DOCUMENTATION AND ARCHITECTURAL ANALYSIS  
OF LITTLE MANOR PLANTATION HOUSE

William Luby Ferguson

A THESIS

Historic Preservation

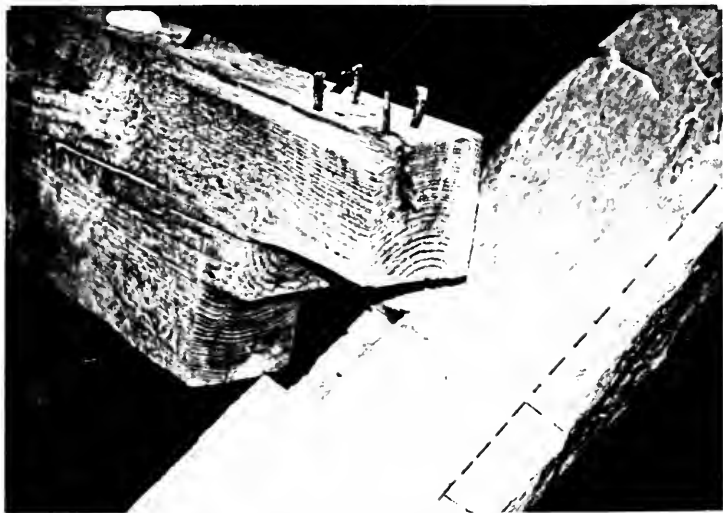
Figure 12: Federal Section Joist and Sill

It is a variation of a shouldered tusk and tenon joint, where the joist laps onto the sill. When the joint is connected, there is a four to five inch gap between the outside of the sill and the joist end, illustrated by the dotted line. Unfortunately, this sill is brown rotted, and normally is twelve inches wide rather than the eight inch width seen. The dotted area represents a band on the outer edge of the sills and plates on which all of the vertical framing members are placed, connected by mortise and tenon joints, and in some cases, nails for secondary studs. The joist is four inches thick and nine inches high. For the purpose of identifying the location of photographed framing details, the Figure Numbers of the photographs match the circled numbers on the framing drawings.

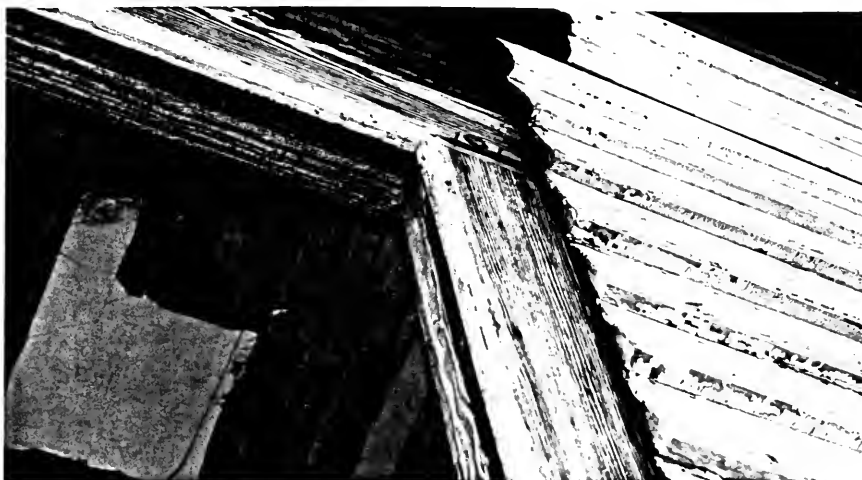
Figure 25: Federal Section First Floor Window Frame

As the photograph shows, the six inch members are mortised and tenoned at the top corners. Channels and stops are molded on the inside edges to receive sashes. Note the unmolded weatherboard to the right of the missing outside casing. As will be discussed later, there is a hierarchy of weatherboards involving four distinct types.

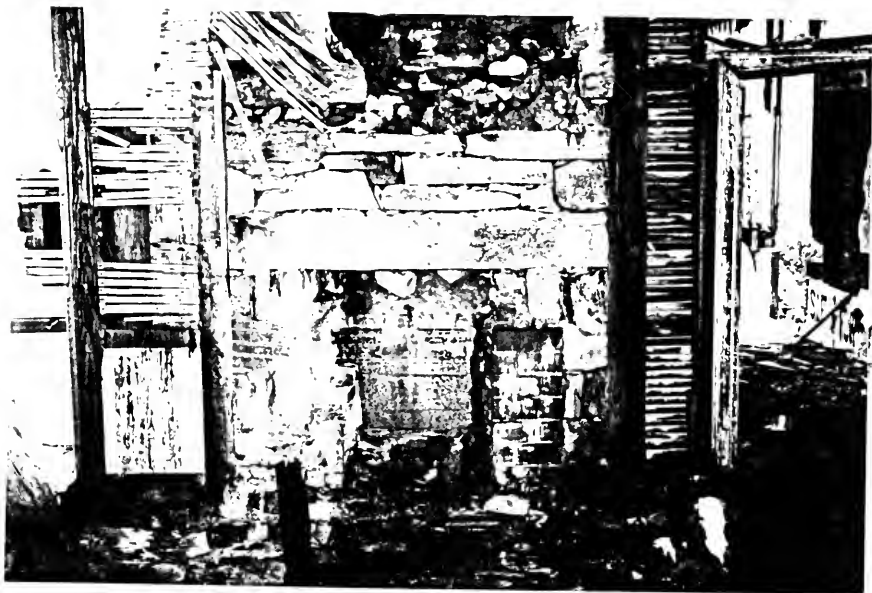
Figure 41: Federal West Parlor Firebox

The two Federal double chimneys service the east and west parlors, the second floor east and west chambers and the two wing chambers. In terms of design, they are similar to the Georgian English basement fireplace, but the Federal parlor fireplaces have taller openings and a coarse of finished brick in the firebox and on the surround. The west parlor fireplace, shown at the top of the next page, also features a back made of iron straps. Mitch Wilds, Senior Restoration Specialist for the North Carolina SHPO, speculates that the installation of an iron back might of been a response to use of coal as a fuel. The iron back would be more resistant to the higher temperatures achieved by coal-burning fires as compared to other materials designed for wood. The firebox was also reduced in size for coal burning use.

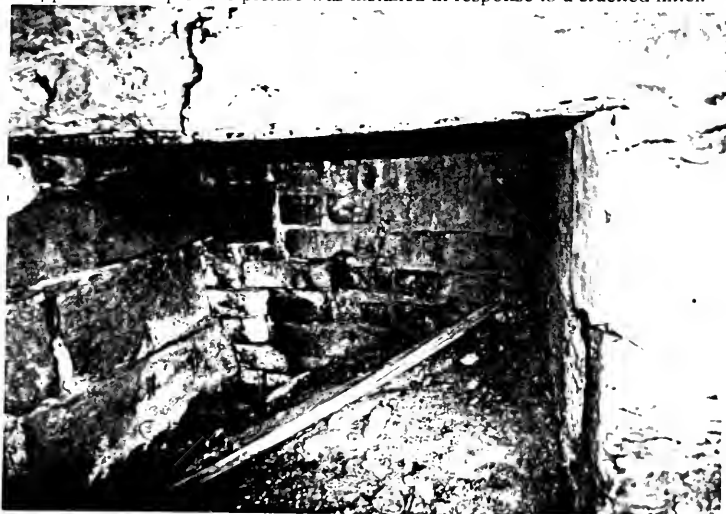
Figure 42: Federal West Chamber Firebox

The only other fireplace in the Federal section accessible for examination was the that of the Federal west chamber. Shown below, it has a brick fireback and a relatively low opening. The iron support at the top of the picture was installed in response to a cracked lintel.

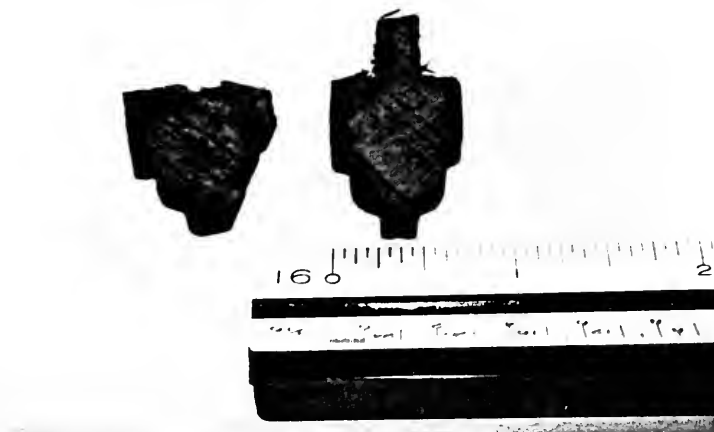
Figure 46: Federal Section Muntins; Cross Hall Transom and East Parlor

Although whole window sashes are missing, two Federal muntin profiles were obtained, one from the cross hall east door transom and one from the southeast window of the Federal parlor. They are shown below. The muntin on the left is from the cross hall transom.

These muntins were compared to other muntin profiles gathered by the North Carolina SHPO. They closely resemble, in form, several North Carolina Georgian structures from the 1780s and 90s, but are considerably smaller and therefore are likely to be from the Federal period.

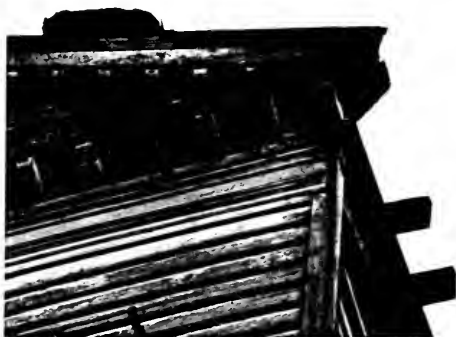
Figure 48: North Elevation; Trim Elements of Federal Main Gable

drawings of these features, but the modillion profiles as shown are incorrect. Figure 48 shows the northwest corner of the main massing. As the modillions project from the building, there is a plain block that is interrupted by a fillet, then the profile curves upward in a quarter round configuration. The picture shows a cyma reversa molding below the modillions interrupted by a fillet. Also shown are a small rake board molding and corner boards, which have a roundel molding at the corner. The silhouettes of a dragon beam and projecting attic joists are visible to the right.

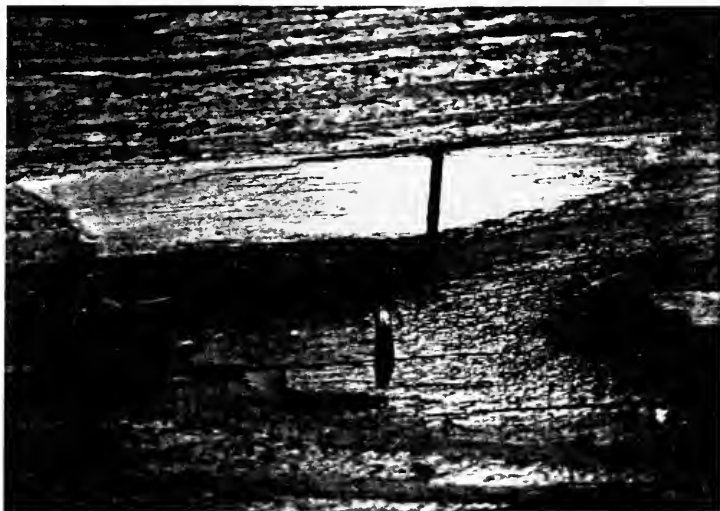
Figure 53: Wrought and Cut Nails in Georgian South Chamber Roof Sheathing

The sheathing boards for the roofs of both sections are wide planks with one inch thicknesses, except in the cross hall, where the sheathing has been replaced with sheathing lath. Nail patterns in the sheathing indicate multiple campaigns of roofing. The next figure shows nails protruding from sheathing in the Georgian south chamber. A wrought nail with a spoon-tipped shank is seen in the lower middle part of the picture, with a cut nail above it. The sheathing of the Federal main roof has early cut nails with handmade heads. In both cases, the sheathing is likely original material.

In addition to these nails, there are modern wire nails of later campaigns, but oddly, no machine-headed cut nails or modern cut nails which one would expect to see for roofs installed in the middle and late nineteenth century.

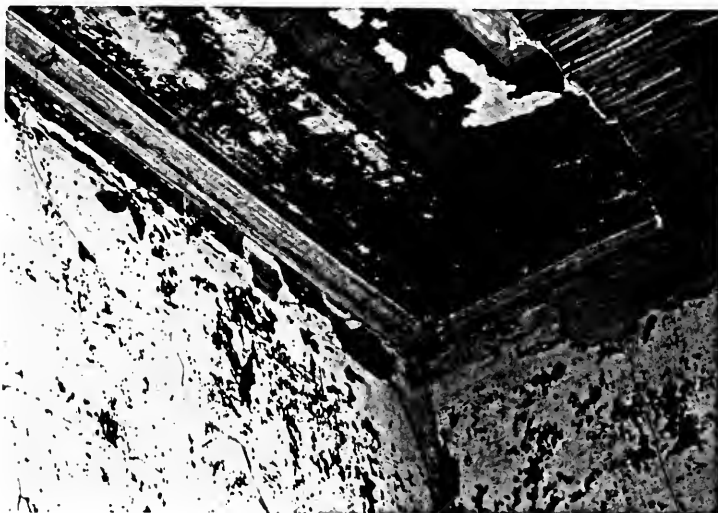
Figure 55: Paint Finishes in Federal East Parlor

A good example of this is provided by the Federal east parlor, the only room in the building other than the Georgian parlor with nonwhite paint on the plaster surfaces. Figure 55 shows the ceiling area at the northwest corner of the room. Part of the elaborately painted ceiling is still intact, but most of the paint has flaked off the wall surfaces. As will later be seen the Frances Benjamin Johnson photographs, the paint finishes in this room were the most elaborate in the building.

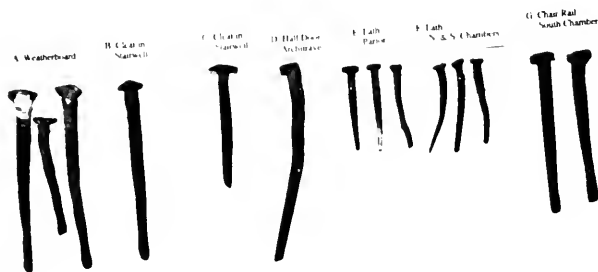
Figure 71: Representative Nail Types of Georgian Section

The dominant nail type used in the Georgian section of the building is the hand wrought nail. Shown in Figure 71, these nails were used for framing elements, weatherboard, exterior trim, second floor interior trim, and flooring. These are represented by labels A, B, C, and G.

All of these Type I nails are two to three inches in length, have spoon-shaped shanks at the ends and have either T-shaped or rose-shaped heads. Of the non-lath nails partially or completely accessible for visual examination, approximately 85% were of the hand wrought variety. The other 15% were completely machine-cut brads used exclusively for first floor interior trim elements. Brads are defined in the eighteenth century as non-framing nails over two inches long, whereas sprigs are nails under two inches, such as lath nails. By the early nineteenth century, brads referred to any non-framing nail. In Figure 71, the completely machine-cut brad is represented by label D. Since this is a Type III nail, produced from 1805 to 1820, it indicates that the trim elements of the first floor of the Georgian section are contemporaneous with the construction of the Federal section, sometime after 1804, the date the estate was transferred to William Person Little.

In terms of chronology, the most interesting nails are the lath nails used in the Georgian section. The lath nails shown as labels E and F in Figure 71 are either Type IIC or Type IV, (early machine-cut nails with handmade heads and early machine-headed cut nails). Most of these are Type IIC nails, produced from 1790 to 1810. This indicates that the lath and plaster in the Georgian section was installed several years after the original construction date of 1781, the time the property was transferred to Thomas Person. It could also indicate that the Georgian section was built in the 1790s. In the deed and will research literature, it is constantly assumed that individuals would immediately build on their newly acquired properties, but there is no actual evidence to support this. Person may have decided to build the structure many years after inheriting the property, bearing in mind he already had a residence in Granville County. In regard to the existence of Type IV nails (1815 to 1830), it is likely they were used for minor alterations or repairs. The absence of completely hand forged nails for lath continues to surprise the author despite the theory just put forward. In the analysis of nails of Little Manor, this is one area that needs further investigation. It does, however, indicate that technology transferred quickly to Little Manor from the more heavily populated coastal settlements.

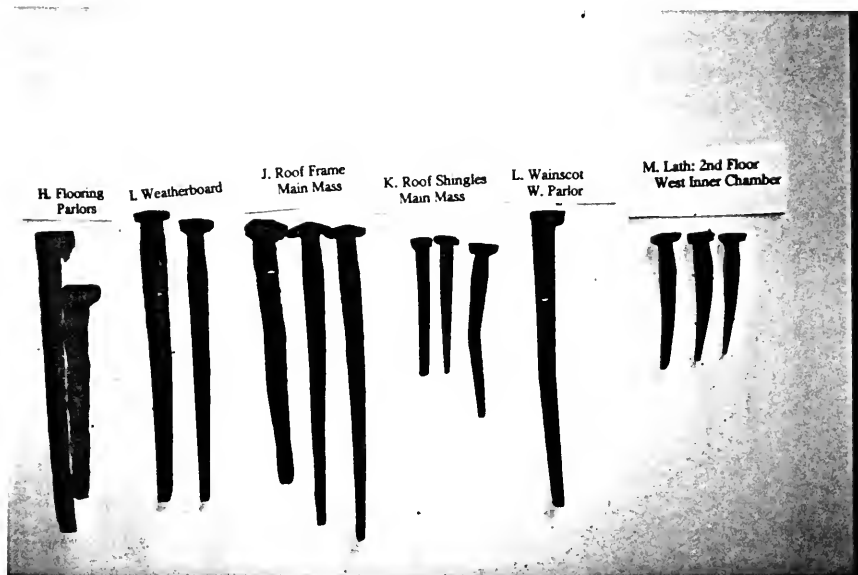
Figure 72: Nails of Federal Main Massing

Analysis of nails in the other sections of the building are less complicated. In the Federal main massing, the nails used in the weatherboard and roof frame are Type IIA nails, early machine-cut nails with handmade heads. Shown under labels I and J (the two to the right) in Figure 72, they were produced between 1790 and the mid-1820s, which fits the time frame of the construction of the main massing sometime after 1804.

Approximately 80% of the framing nails examined in the Federal main massing are of the Type IIA variety. The other 20% are wrought nails used for clinching purposes in braces (Label J, on the left) and some of the small framing members. For roof shingles, sheathing boards, and lath, the nails used were Type IIA and Type IIC. Type IIC nails were manufactured until 1810, so this is compelling evidence that William Person Little built the

The fourth main nail type in the Federal main massing is Type III, completely machine-cut brads, produced between 1805 and 1820. These nails match the trim nails used in the Georgian section and are seen under label L in Figure 72. The flooring nails of the main massing are identical to the trim nails and are seen under label H. They appear slightly oversized because of their corroded condition.

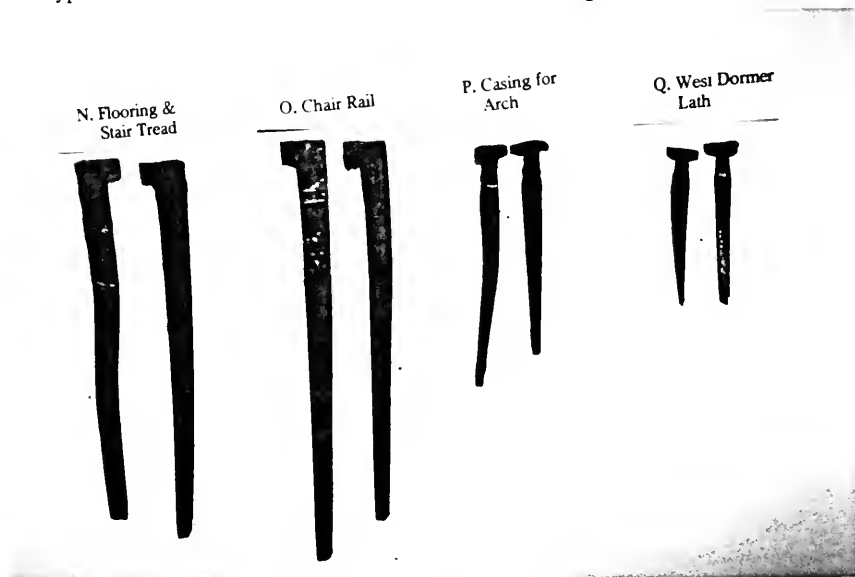
Figure 73: Nail Samples From Cross Hall

Nails taken from the cross hall area match those of the Federal main massing, which indicates the cross hall was built at the same time as the main massing. Shown in Figure 73, they are Type III nails (labels N and O) and Type IIA and Type IIC nails (labels P and Q). The Type III nails are used in all first floor sections of the building.

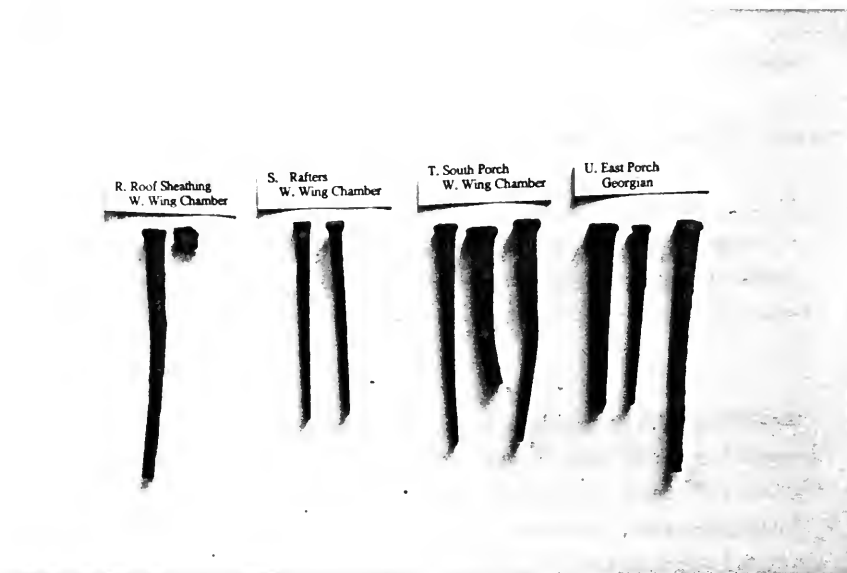
Figure 74: Nails of Rear Porch Structures and Federal West Chamber Roof

All of the porches other than that of the Federal main portico are in a state of collapse, but sections of these structures are still intact, lying on the ground. About 75% of the surviving nails of the framing elements and weatherboard for the fallen porches off the south elevation of the Federal section and east/west elevations of the Georgian section are built with Type IV nails and there are no earlier cut nails. It is likely that these porches and the Federal wing chamber roofs were constructed at some point after the introduction date of these nails after 1815. A few of these nails are shown in Figure 74.

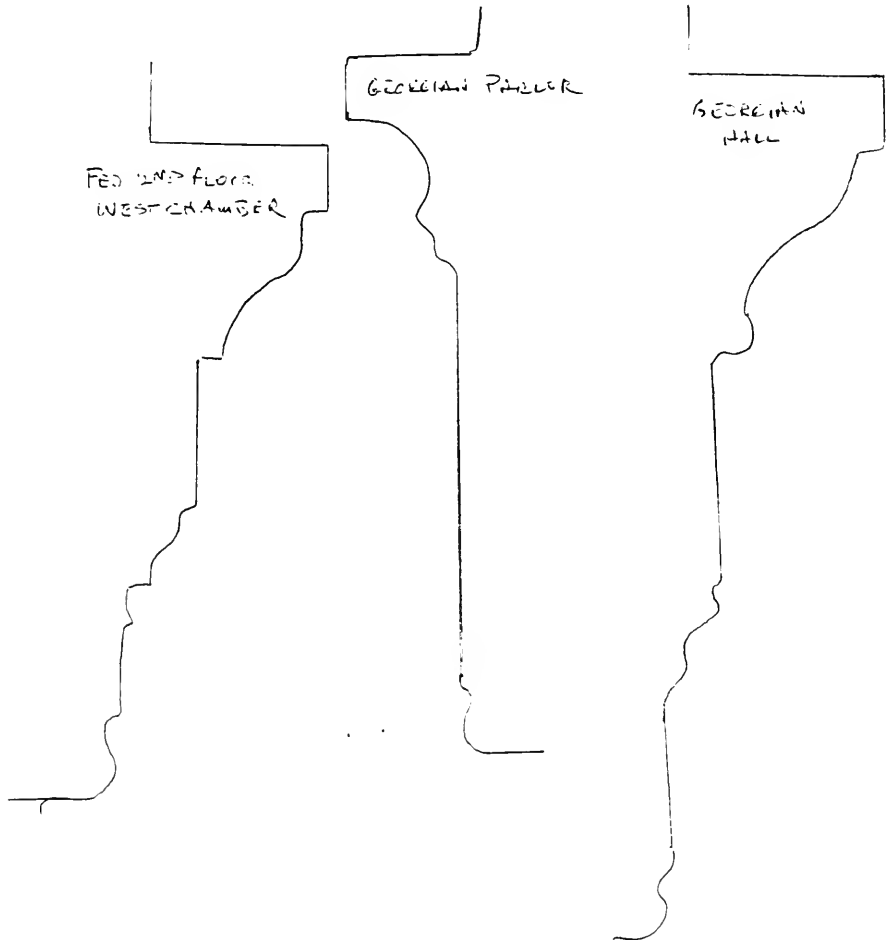
Figure 75: Molding Profiles of Little Manor

In addition to nails, molding profiles are valuable evidence in determining building chronology. They are less reliable as dating tools, because they reflect style, but nonetheless can provide important information when used with other evidence. Of seven profiles taken, three were deemed good enough for presentation purposes. Accuracy in obtaining profiles is a tricky process, because of interfering paint layers and the limitations imposed by the size of the keys of the metal profile gauge. In the three profiles shown in Figure 75, the details of the band moldings at the top of each profile are the most accurate.

The Georgian section hall and Federal second floor west chamber door profiles closely resemble other structures built between 1771 and 1798 in the contours of the band moldings. After 1798, the band moldings differ dramatically. Of particular interest is the comparison between the Federal chamber profile and the Georgian hall profile. They are quite similar, although the Federal chamber profile is scaled down. The Georgian parlor profile is unique in that has cavetto contour below the top fillet rather than the cyma reversa molding common to most of the other profiles.

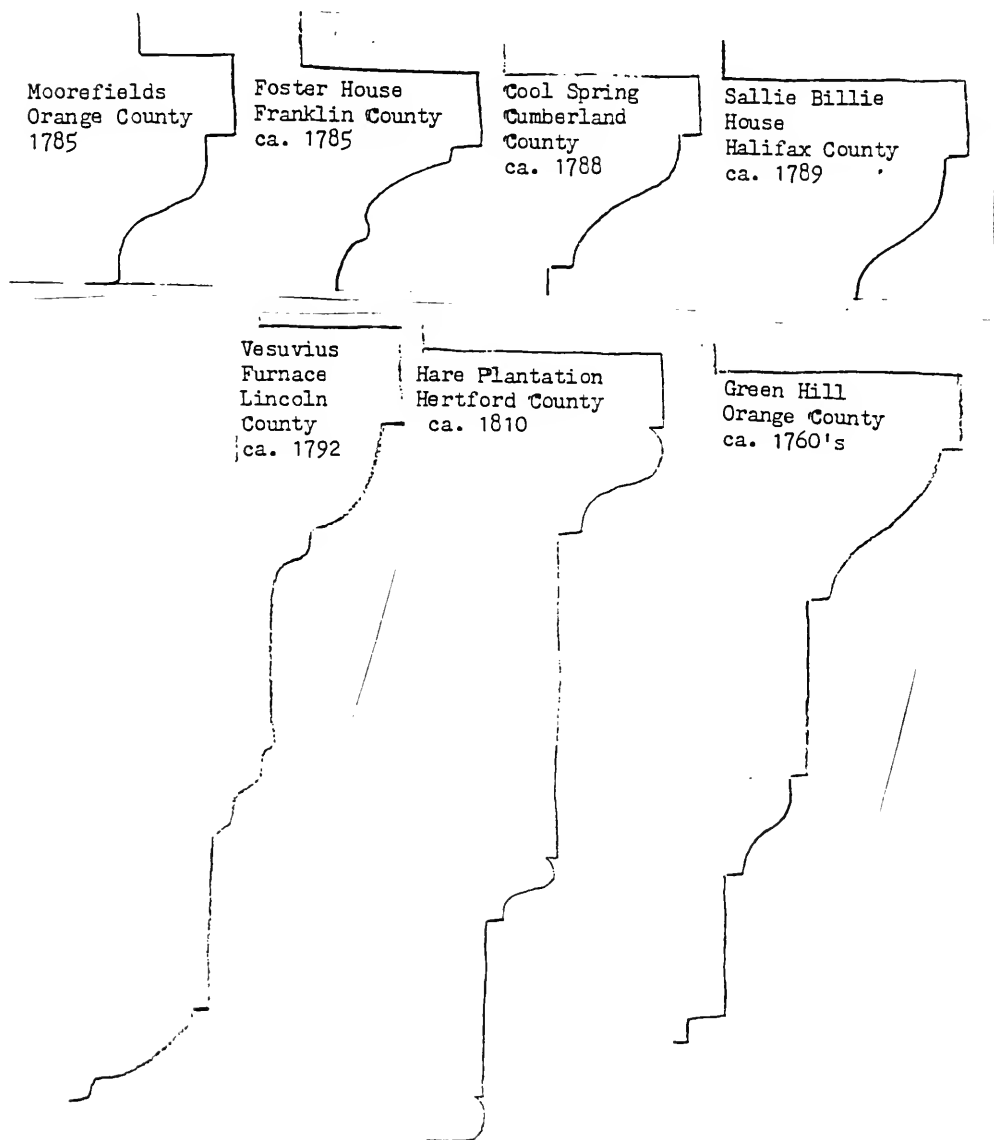
Figure 76: Molding Profiles of North Carolina Dwellings

Within rooms, the profiles match from one door surround to another, but no two profiles match when comparing one structure to another. Figure 76 show several profiles obtained by the North Carolina SHPO of other structures in North Carolina.

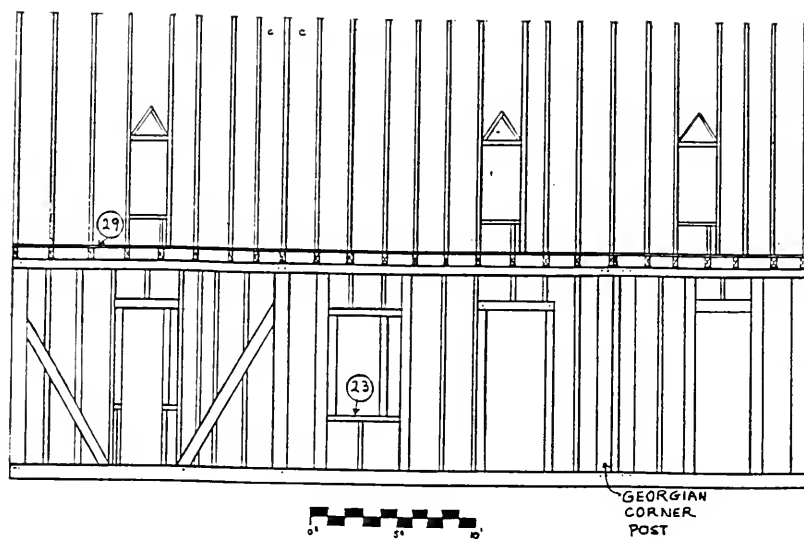
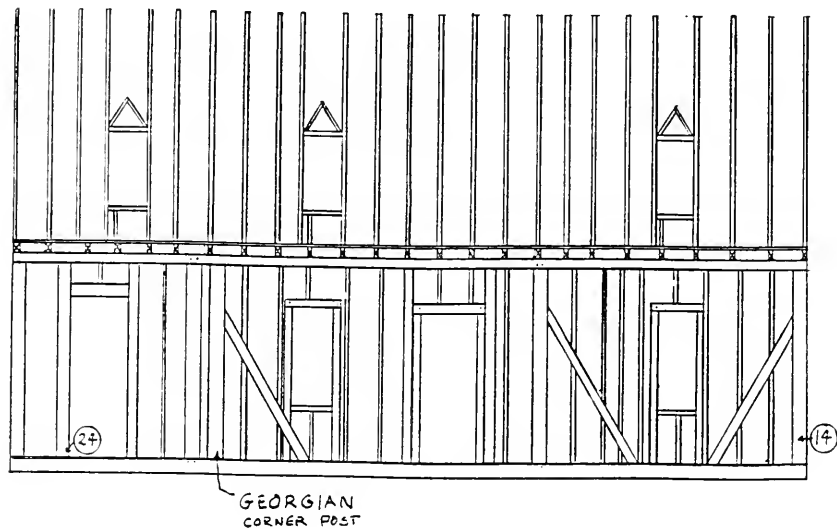
Figure 77: East (top) and West (bottom) Elevations of Georgian/Cross Hall Section

Although changes in the interior finishes of the Georgian section can be interpreted in different ways depending on the type of finishing material being analyzed, this does not apply for changes in framing elements. In Chapter Two, the changes in door and window openings of the Georgian/cross hall section were briefly discussed. Analysis of the framing elements provide additional clues as to what the original configuration of the windows and doors looked like during the original construction campaign of this section. The framing elements of the east and west elevations of the Georgian/cross hall section are shown in Figure 77 on the next page. On the first floor, each elevation has four openings and the openings line up from east to west. As viewed in the elevation drawings, those openings seen on the left of the east elevation line up with the openings on the right of the west elevation. Beginning with the

far left of the east elevation, it can be seen that the opening was converted from a window to a door. The surviving framing elements of a window match the framing elements of the opening on the other side, seen at the far right of the west elevation. Hence, the original openings of this room consisted of two windows, typical of a Georgian parlor.

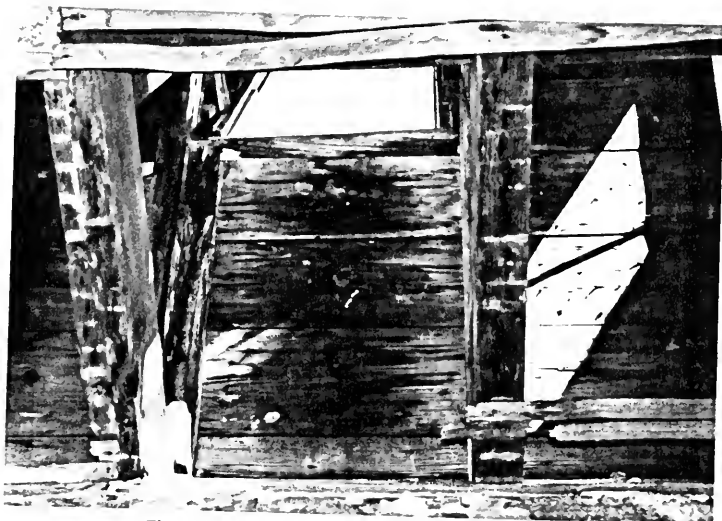
Figure 78: Georgian Dormer Frame Elements

Early alterations were also performed on the second floor of the Georgian section. As seen in both Georgian section elevations, the dormers do not directly line up with the openings below. This is because the carpenters were restricted by the roof frame already in place. They had to cut through one rafter as seen below the sills of the dormers, then installed a companion rafter for structural support. Figures 78 and 79 illustrate this process. Figure 78 shows the original rafter (on the left) cut to make way for the dormer structure. Figure 79 shows a wind brace cut for the same reason, seen on the middle left. Ordinarily, the wind brace would end at the rafter with a half lap joint cut into the rafter rather than the brace being completely sawed off.

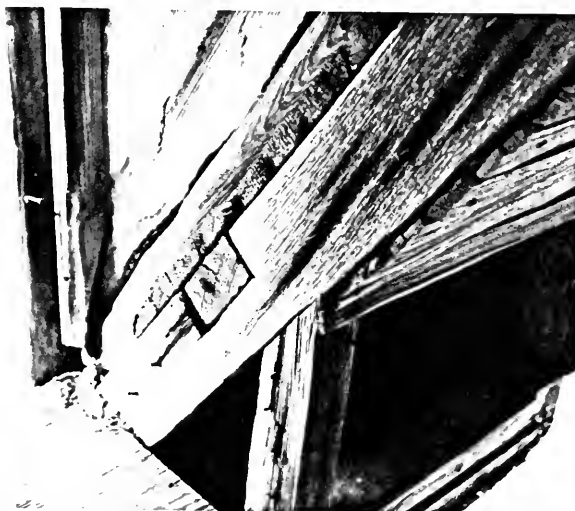
Figure 79: Wind Brace in Georgian Dormer Frame

When the dormers were installed could not be ascertained, but it likely it occurred before the construction of the Federal section because of the lack of Type IIA cut nails in the framing elements. The occupants may have lived on the first floor, then decided to expand into the half story space.

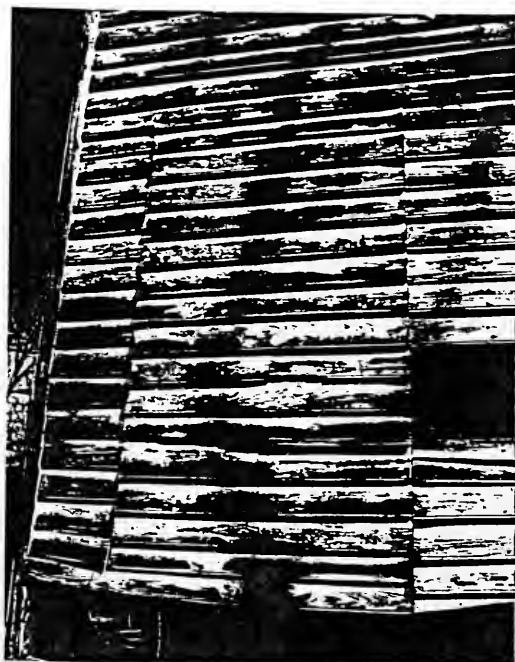
Figure 80: Covered Doorway on Georgian South Elevation

A final alteration in the Georgian parlor occurred late in the building's history. Shown in Figure 80, a door was sided over with weatherboard at the southwest corner of the Georgian south elevation. This door is shown in the L. Scott Garner floor plans of 1964 and was covered at some point afterward. The frame inside is still intact and matches the other jambs in the Georgian/cross hall section.

The date when this doorway was covered is a mystery. In the Garner plans, the door is shown, but is covered in a 1925 photograph seen in Figure 84.

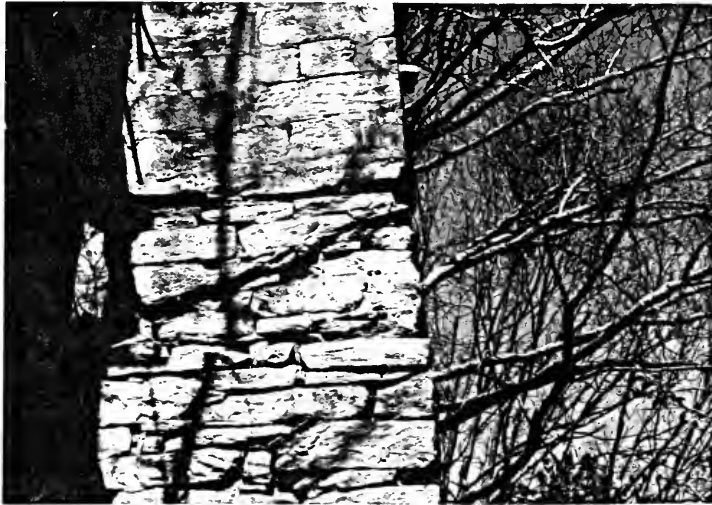
Figure 82: Ghost Mark of Front Gable Roof on South Elevation of Federal East Chimney

The most significant early alteration that occurred at Little Manor, and one that impacts the architectural history of tripartite North Carolina structures, occurred with changes to the Federal wing chamber roofs. In 1998, restoration contractor Dean Ruedrich, with Mitch Wilds, discovered the ghost marks of front gable roofs on the chimneys near the wing chambers. Shown in Figure 82, the mark of a twenty-five degree gable roof is clearly visible.

Ruedrich and Wilds theorized that the original front gable roofs were at some point rotated ninety degrees to give the roof structures their current side gable configuration. The thesis investigation confirms this theory. It begins with a major design flaw during the original Federal construction campaign. The builders were trying to create a tripartite principal elevation with three matching ornamented small front gables beneath one large main front gable. The front gables of the wing rooms were designed to be the same height, roof pitch

Although visually pleasing, the problem with the design is that during rain storms heads of water rush down the roof surfaces of the gables directly onto the chimney and weatherboard of the side elevations of the main massing. Unless very large valley gutters or wide metal flashing materials are used, there is no way the water is prevented from splashing onto the weatherboard and into its overlapping seams. Heads of water can also penetrate into the mortar joints of the chimneys. The result is that these vulnerable areas began to deteriorate rapidly, and the owners were forced to solve the problem by rotating the roof structure to its current form so the flow of water ran off the eaves down onto the ground or into a gutter.

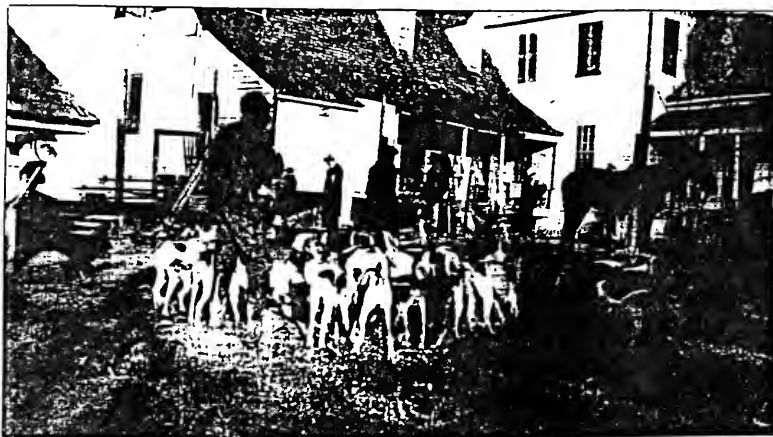
Figure 84: 1925 Photograph of Little Manor

In the analysis of nails, it was determined that the porch structures on the rear of the building were constructed sometime between 1815 and the 1850s. Two of these are seen in Figure 84, which shows a view of Little Manor taken from the southeast in 1925, during a fox hunt. One porch kicks out from the Georgian roof in the center of the photograph and the other projects from underneath the eaves of the Federal east wing chamber roof. The fact that the wing porch is not a continuation of the main wing roof indicates it was probably built

separately, sometime after the wing side gable roof. All of the roofs in the photograph have wood shingles with square butt ends, likely the roofing material before the installation of the standing seam metal roof. Wooden shutters are visible on some of the windows and there is an outbuilding to the far left.
